FAA-RD-75-118

ANALYSIS OF THE EFFECT OF CONCORDE AIRCRAFT NOISE ON HISTORIC STRUCTURES

Robert L. Hershey
Russ J. Kevala
Sharon L. Burns

Final Report

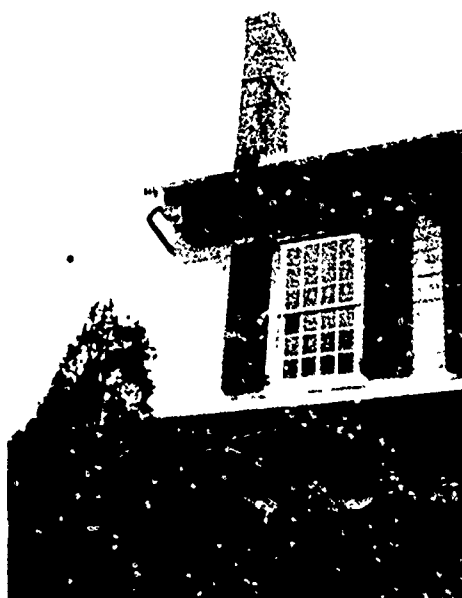
FIGURE III-3
Chimneys and Pent Wall
at Sully Plantation

There are two massive twin chimneys and brick pent wall on the west side of the house as shown in Figure III-3. Today the chimneys have been partially reconstructed at two different times due to damage from lightning. The mortar was basically composed of lime mortar, crushed oyster shells and sand used from the surrounding area. The foundation is original and made of Virginia red sandstone. The mortar used in the foundation is identical to that used in the chimneys. Originally the partial basement had a tamped dirt floor.

In analyzing the breakage probabilities of the chimneys they were modeled as cantilever beams with additional support from the brace as shown in Figure III-3. The type of failure which was considered was the first cracking of the mortar from an overturning force from lateral vibration. The approach of Chapter II yielded an estimate of the probability of failure of 7.9×10^{-10} for each Concorde overflight on each chimney. Considering the proposed Concorde schedule and the fact that there are two such chimneys, the failure of a chimney from Concorde noise has a probability of occurrence of 2.3×10^{-6} per year. This is equivalent to an estimate of 440,000 years between failures.

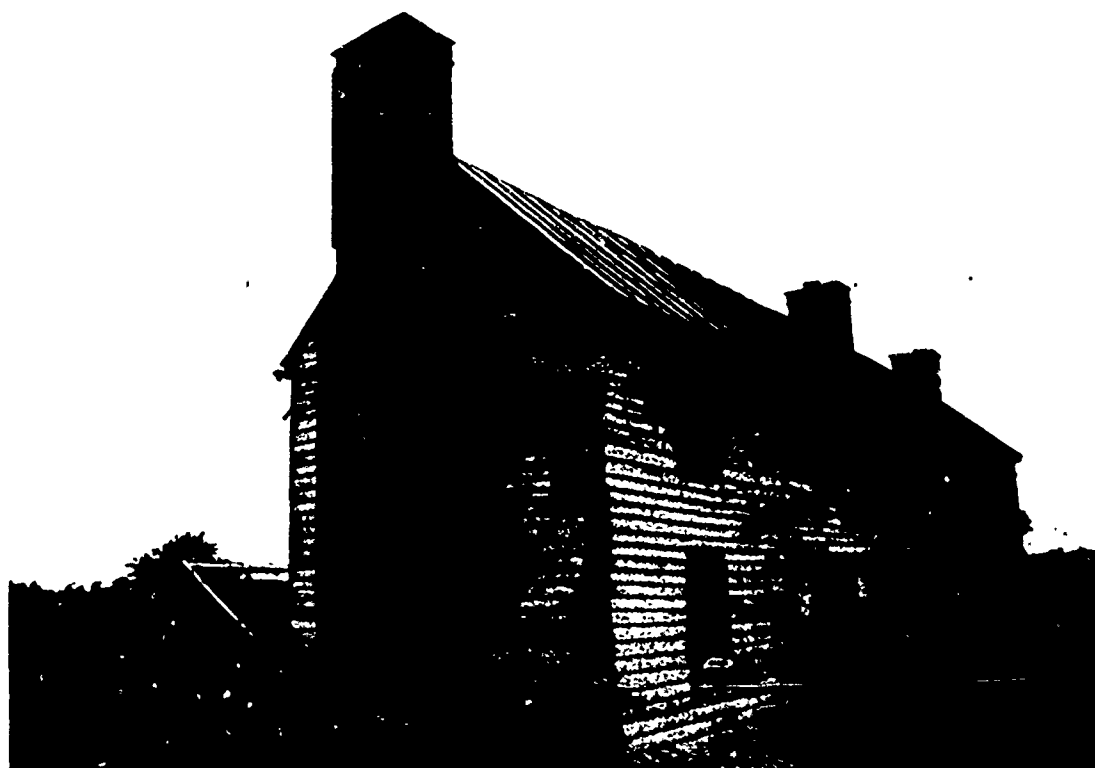
FIGURE IV-1
Dranesville Tavern

The Tavern is currently in a state of disrepair and several lites are cracked. Most glass is considered to be original, though most or all of it may be replaced during the planned reconstruction. The average lite size is 10 by 12 inches, with a thickness of 1/16 inch. The strength distribution and stress factors will be similar to those at Sully Plantation.

Using the procedure outlined in Chapter II, the probability of failure of a cracked lite is obtained as 5×10^{-22} per overflight. Assuming that all 210 lites are cracked, this would mean one failure per 6.55×10^{15} years due to the noise from Concorde overflights.

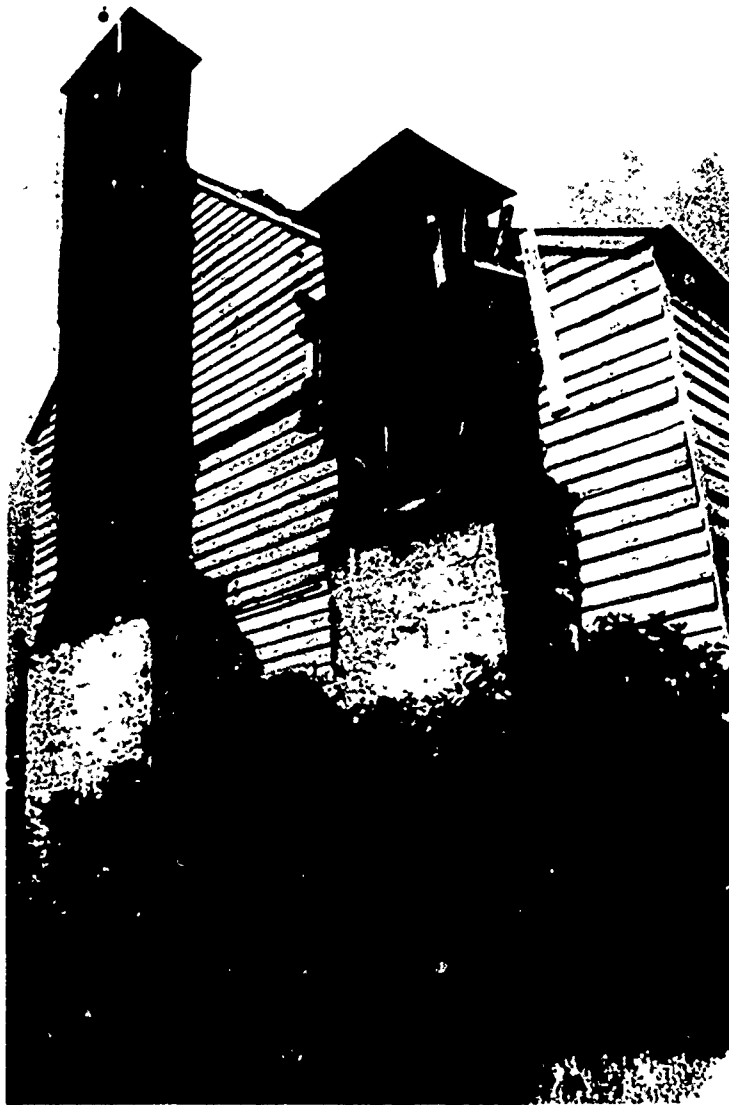
FIGURE IV-2
Unrestored Chimneys at
Dranesville Tavern

The Tavern has four chimneys of stone and mortar construction. All the chimneys are in a very unsound condition and the chimneys on the west side are held together temporarily by wooden scaffolding (Figure IV-2). The eastern chimney appears today as it did in the earliest period. The west chimneys were completed c. 1850, and the taller kitchen chimney appears to be made of two distinct sections, with the stonework above the present roof level not as well and carefully constructed as the work below. This chimney is the one most likely to suffer damage from Concorde overflights. It has an unsupported height of 20.67 feet above the shoulder at the first story level.

One of the mechanisms of failure of the chimney would be caused by excessive tension in those portions of the mortar that are not under any compressive loads due to the unevenness of the stone layers.

The mean value of breaking strength of mortar under tension is 6134 psf. Equating this to the maximum bending stress, the overpressure required for failure is obtained as 29.3 psf.

Using the method outlined in Chapter II for chimneys, the probability of failure of the kitchen chimney is 1.2×10^{-15} per Concorde overflight, or once in 5.8×10^{11} years. The probabilities for failure of the other three chimneys will be lower because of the lower induced stresses in them.
